## Thermal Imaging Survey Report

**Survey Date:**22<sup>nd</sup> March 2022**Report Date:**6<sup>th</sup> April 2022

## General Building Description

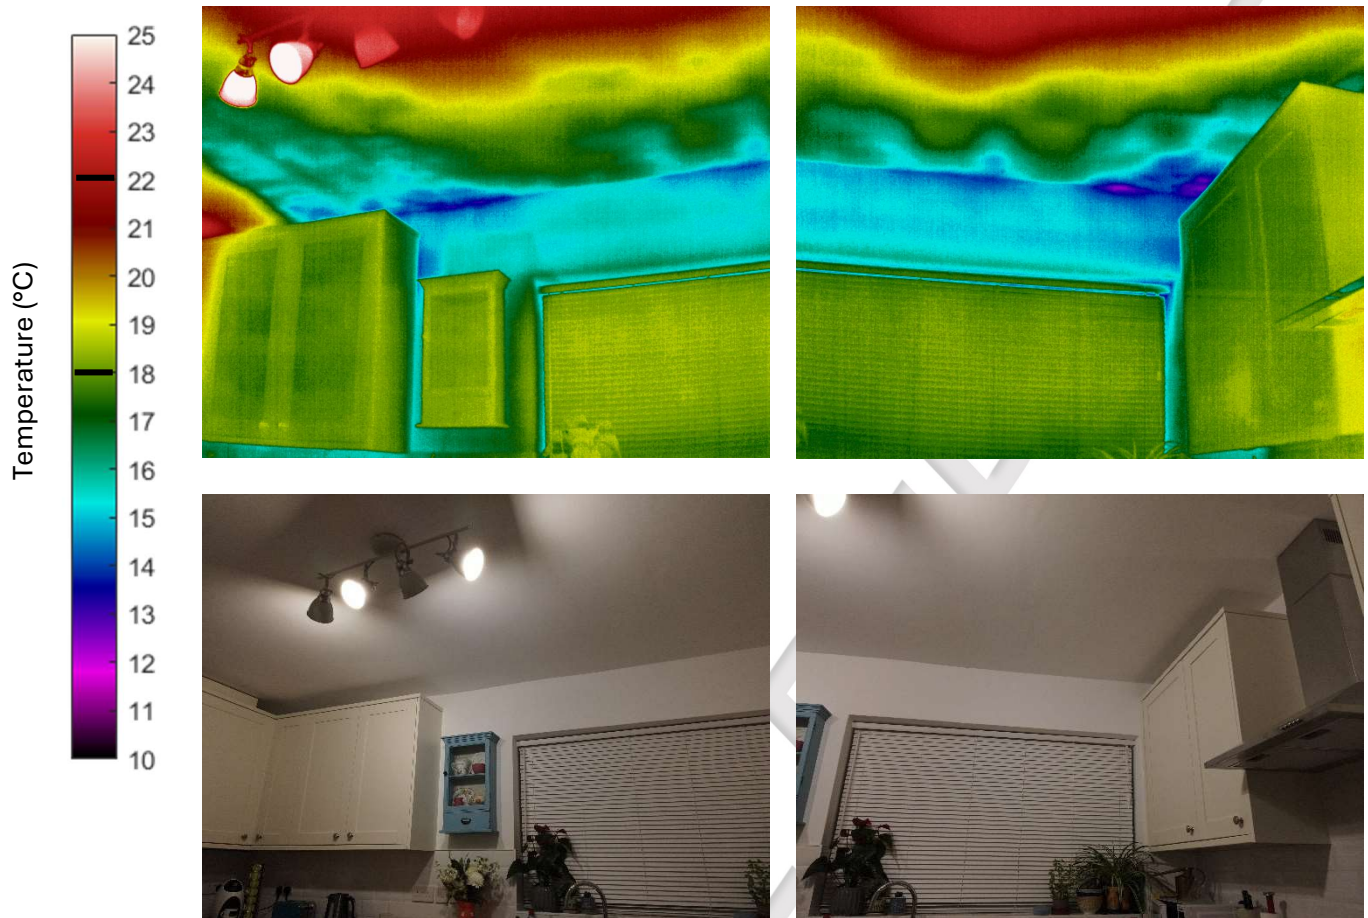
**Figure 2: View of Front Door (View 3 (left) and 4 (right))**

In these images, the scale has been further reduced at the lower end to +10°C to show include the colder areas of the image over end wall of the kitchen. The view is split to capture both ends of the external kitchen wall. The cold areas are indicative of poorly fitted insulation at the junction between the ceiling joists and the rafters.

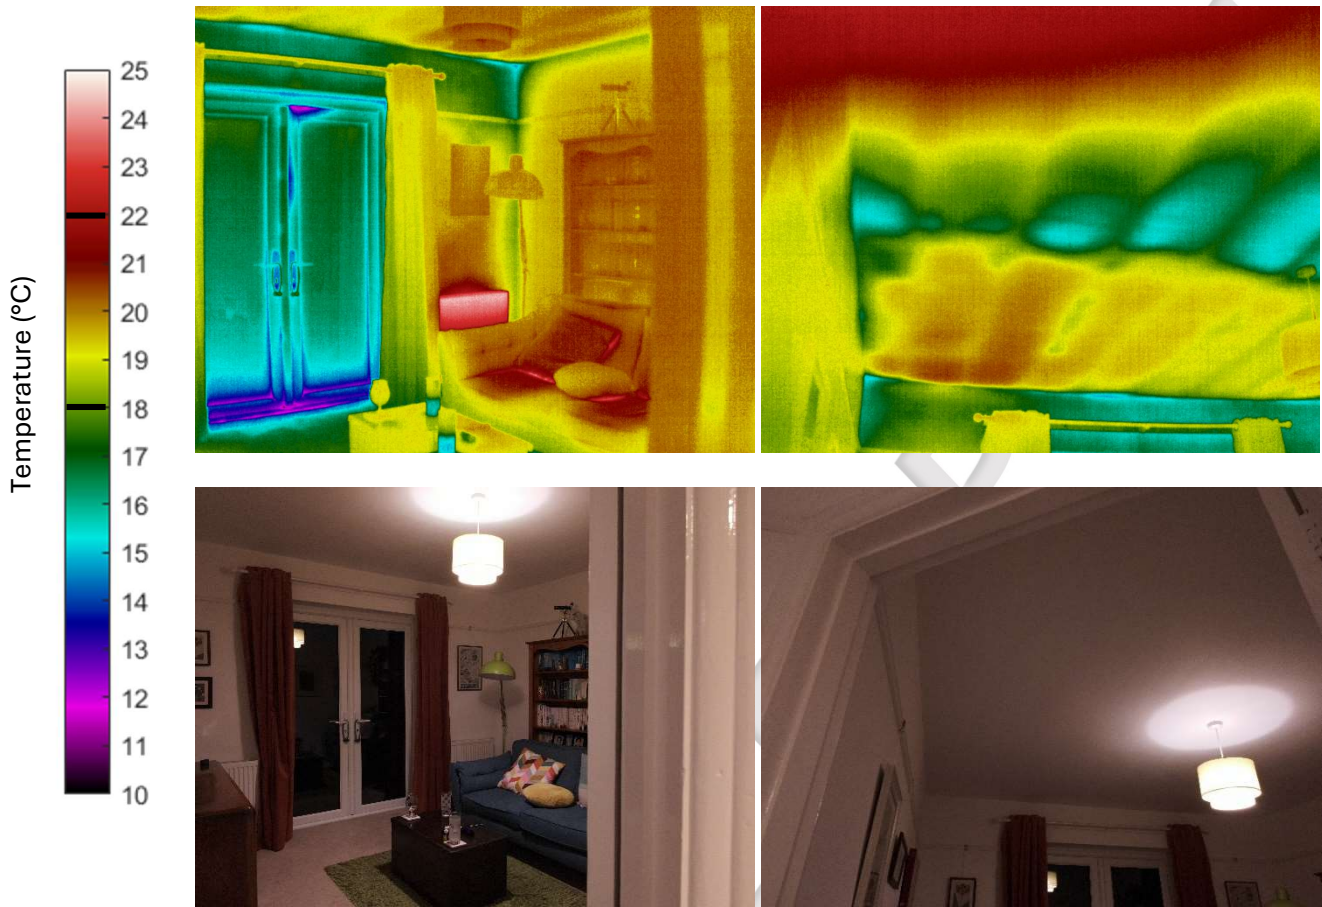
**Figure 3: View of Lounge Ceiling (View 6 and 7)**

There is a significantly cooler area present on the ceiling in the Lounge; this is coincident with the stud wall on the first floor dividing the eaves cupboard space from the main bedroom. The cause of this is not certain but could result from colder air ingress from the room space to the ground floor ceiling. There is evidence of air ingress at the upper portion of the right hand UPVC French doors (shown by the darker colours). The seal here should be checked and repaired/replaced if required.

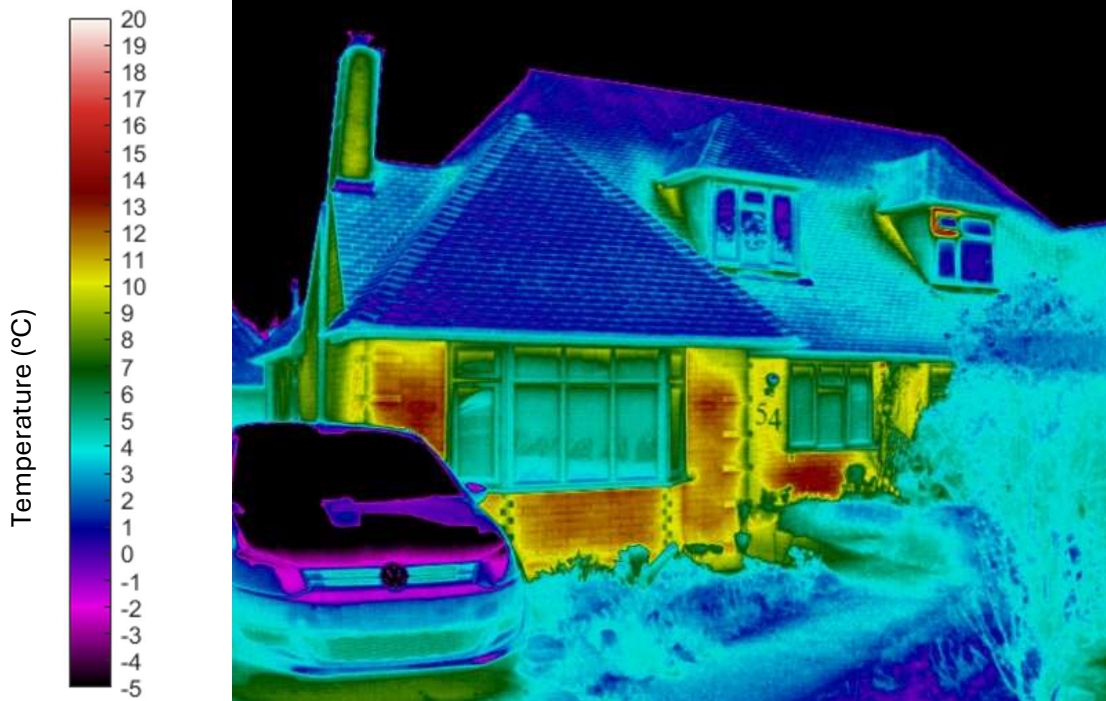
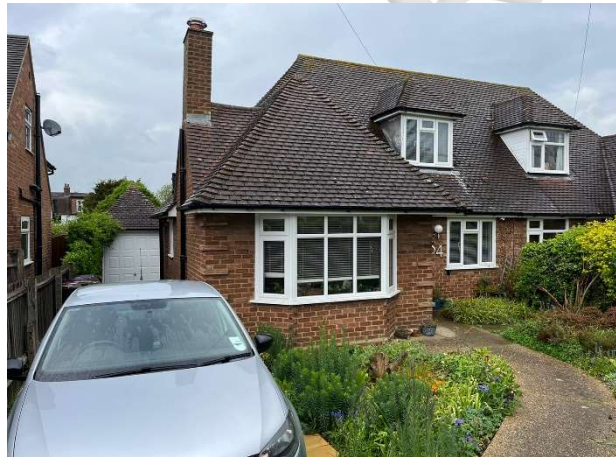
**Figure 4: View of Southern External Profile from Road**

The southern aspect shows noticeably warmer indicative temperatures. Although there will likely be a component of residual solar gain during the day, the apparently high temperatures of these walls indicate significant heat loss through these surfaces. This could be indicative of cavity wall insulation missing in these areas. Due to the reflective nature of the roof tiles and the clear, cold sky, no cause for concern should be raised regarding the apparent cold temperatures in these areas.
